**National Highway
Traffic Safety
Administration**

CALSPAN ON-SITE AIR BAG DEPLOYMENT INVESTIGATION

CALSPAN CASE NO. 91-08

VEHICLE - 1991 FORD TAURUS

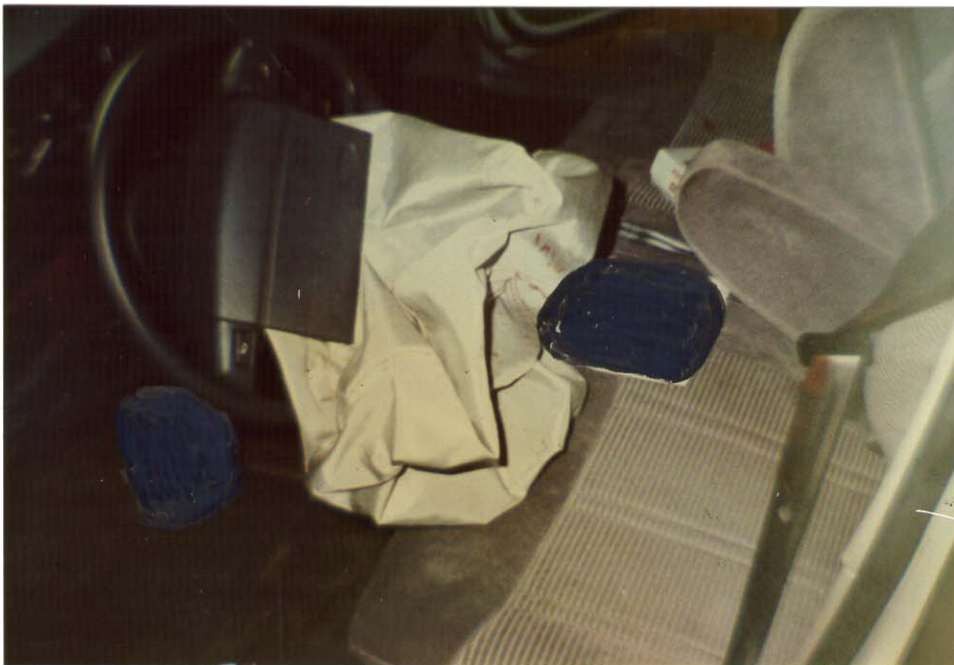
Closeup View Of The Upper Module Cover Flap.

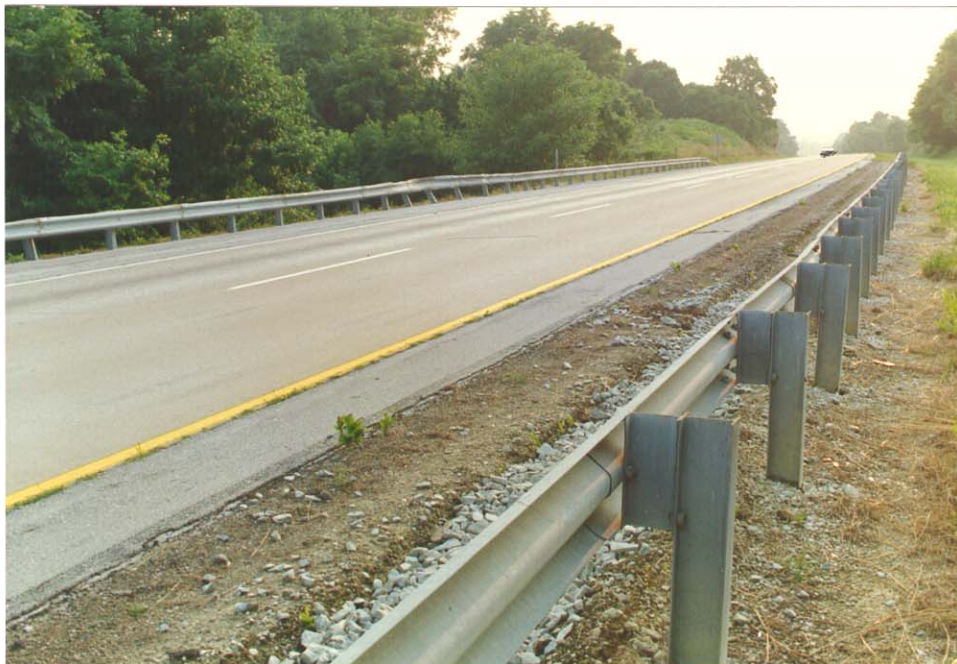
Lookback View Of The Ford Taurus' Trajectory.

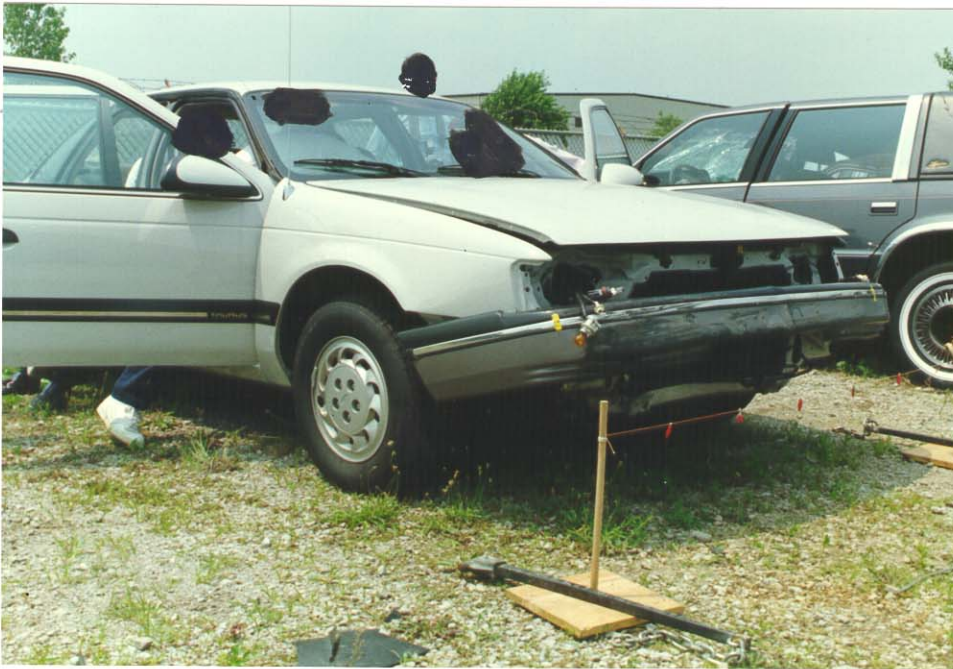
Right Front Three-Quarter View.

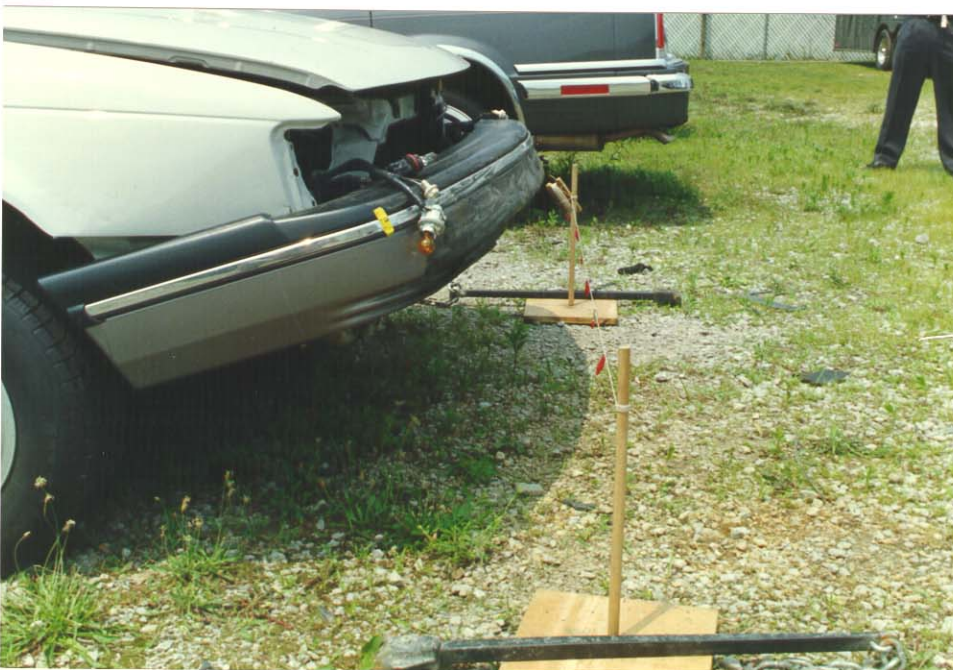
Primary - The frontal area of the Ford Taurus impacted a W-beam guardrail which resulted in minor damage to the bumper and adjacent components. Maximum crush was 2.0" that was located at the right corner of the bumper. Direct contact damage on the bumper face began 22" left of the vehicle's center line and extended 52.4" to the right corner. The impact compressed both bumper energy absorbing devices (EADs) which resulted in a combined induced and direct contact damage length of 60.25" that involved the entire bumper. The left bumper EAD compressed 0.4" while the right unit compressed 1.6". Both EADs returned to their original pre-crash positions. Crush values were measured at six equally spaced increments across the front bumper and were as follows:
C₁=0", C₂=0", C₃=0", C₄=0.1", C₅=1.0", C₆=2.0".

Perpendicular View From The Right Front Corner Area
Showing The Extent Of Crush.

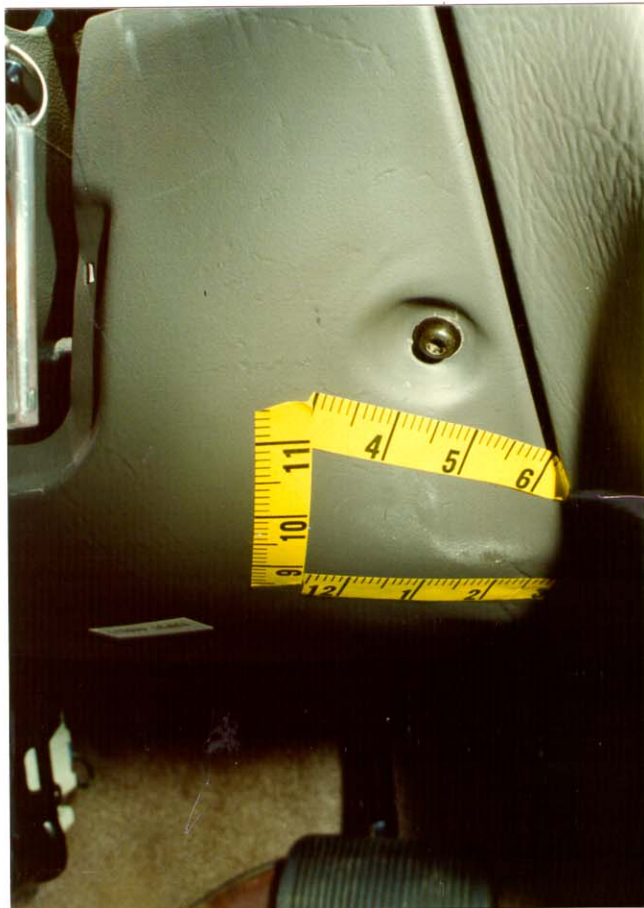
Driver's Left Facial Contact
To Left Upper A-Pillar.

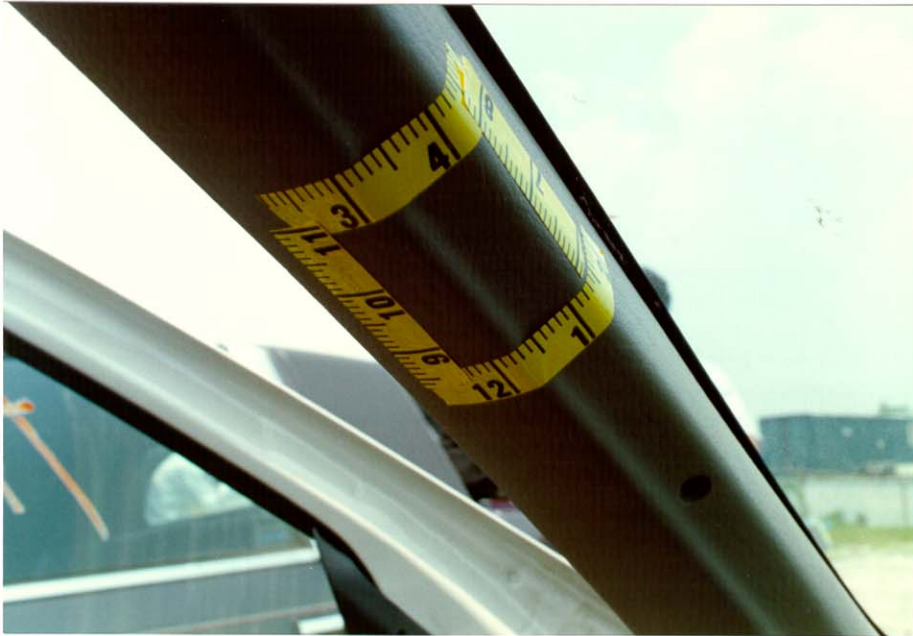
Closeup View Of The Faint Tissue Transfer On Left A-Pillar.

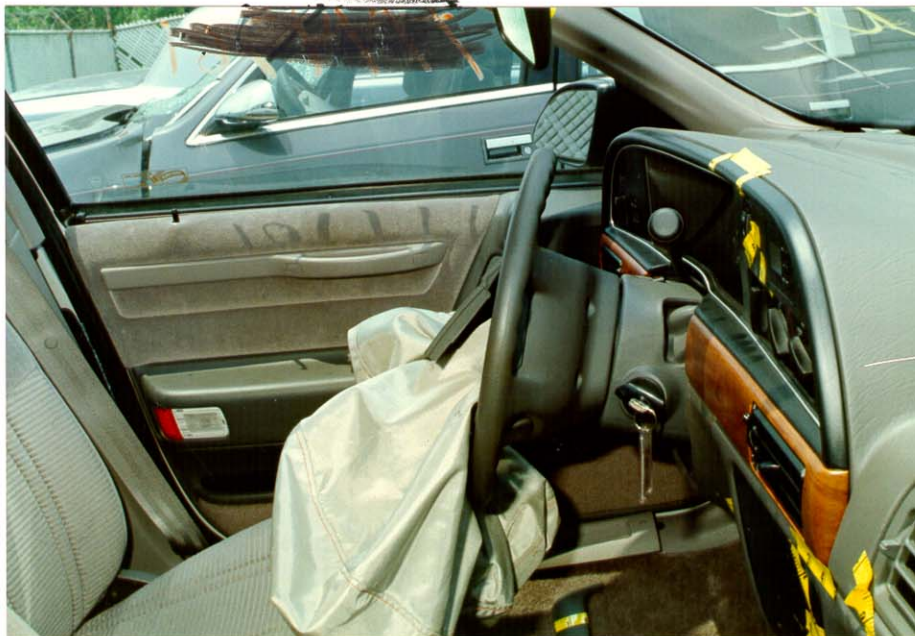
The interior of the Ford Taurus sustained minor damage that was associated solely with occupant contact. The driver's thoracic area loaded the steering assembly through the air bag and deformed the upper steering wheel rim 0.75" forward. Her loading force was transmitted into the steering column which compressed the energy absorbing steering column 1.1". The driver's involvement with the steering assembly fractured and deformed the right cruise control switches that were located between the upper and lower spokes, adjacent to the air bag module. Her knees contacted the steel knee bolster 7-8.25" and 13.9-15.1" left of center. Although no residual damage occurred to the bolster, scuff marks identified the contact areas. The driver's left facial area impacted the mid left A-pillar. Again, no residual damage occurred to the pillar; however, tissue transfers evidenced the contact area. Blood stains were noted to the face of the deployed air bag and on the active belt webbing in the area of the latchplate.

Deformation To The Upper Steering Wheel Rim From Driver Loading.

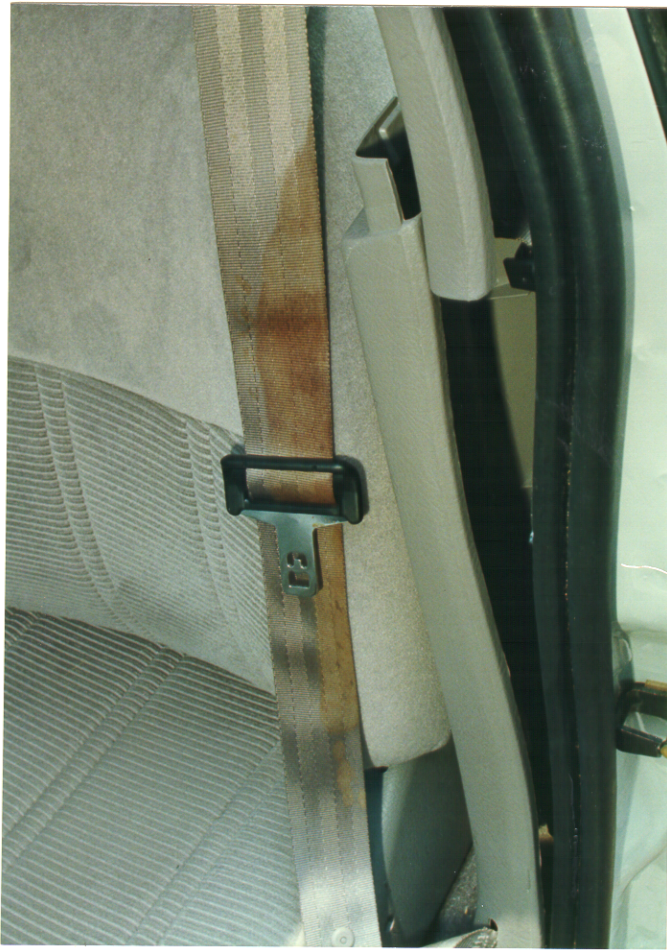
The driver rebounded into the left front seatback then slumped forward where she came to rest. The head injuries produced bleeding from her left ear and nose. Blood stains were visible on the air bag and the shoulder belt webbing in the vicinity of the latchplate.

Blood On The Belt Webbing.

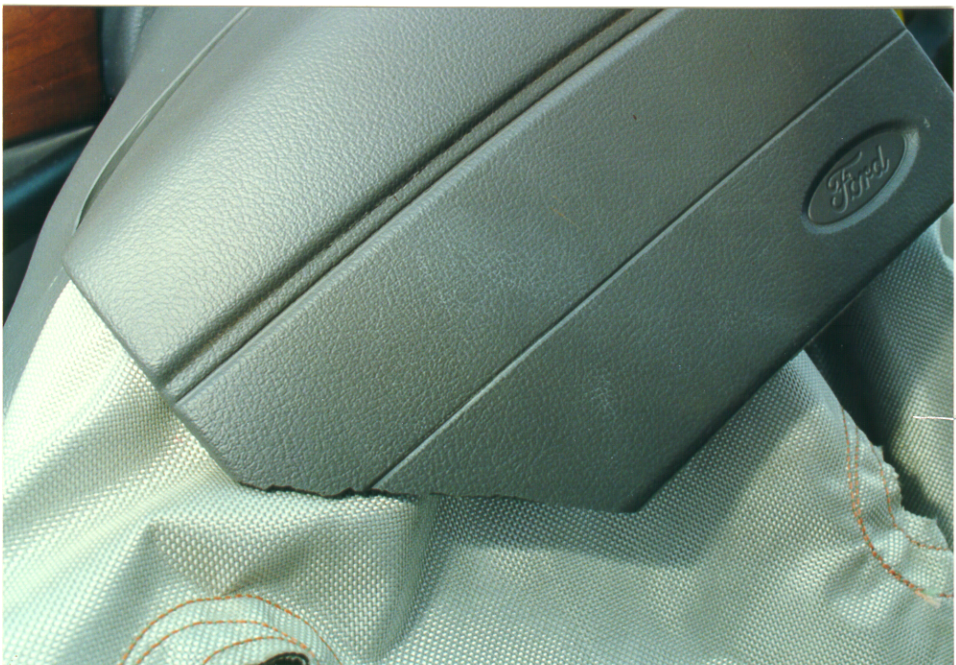
Powder Transfers On Air Bag Module Cover,
Left Lower Corner Of Flap Had Been Cut Away.

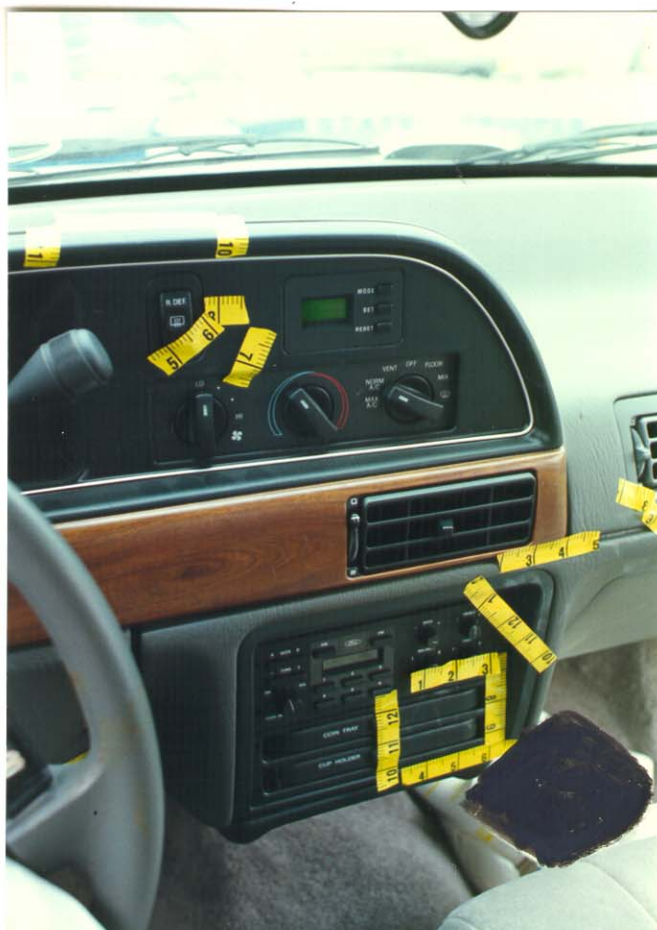
The center front occupant's extremities contacted the center instrument panel area, depositing fabric transfers to the contacted components. Her left arm contacted the upper instrument panel 4.25-6.75" left of center. Her right arm possibly contacted the upper panel at the rear defroster switch 3.75-4.5" left of center. A scuff mark evidenced the contact area and was located 2.5-3.1" below the top surface of the instrument panel. The center front occupant's knees contacted the mid and lower instrument panel in the areas of the air vents and cup holder. Fabric transfers extended 0-6.75" right of center and 8.75-12.75" below the top surface of the instrument panel.

Center Front Passenger Contact
To The Center Instrument Panel
Area.

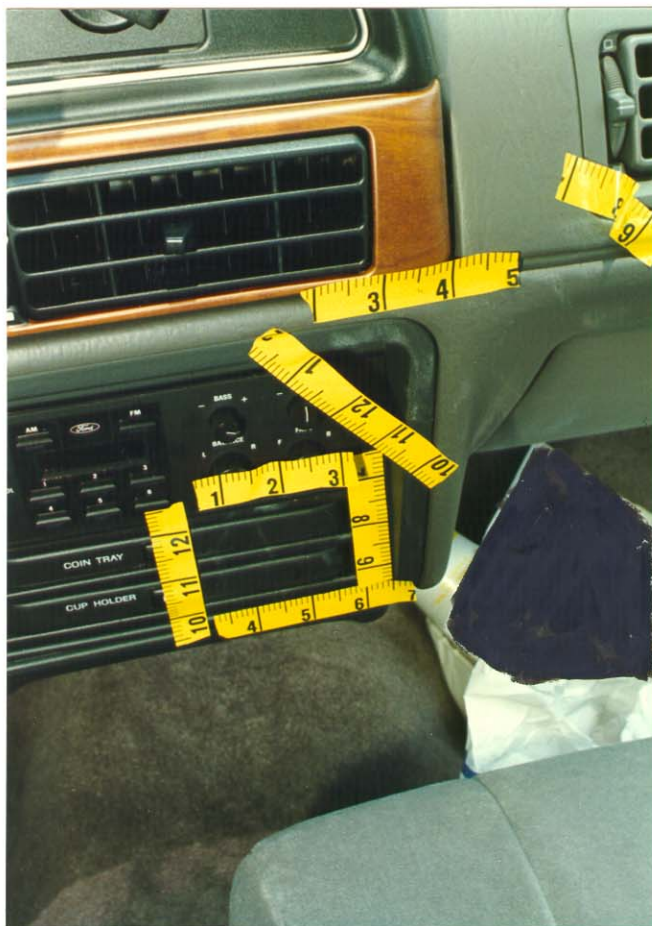
The center front occupant was reportedly wearing the active lap belt loose around her pelvic region. She was asleep at the time of the crash and was probably slumped to her right. At impact she moved forward and to her left and contacted the instrument panel with her upper and lower extremities which did not result in injury.

Knee Contacts To The Lower
Instrument Panel Area.

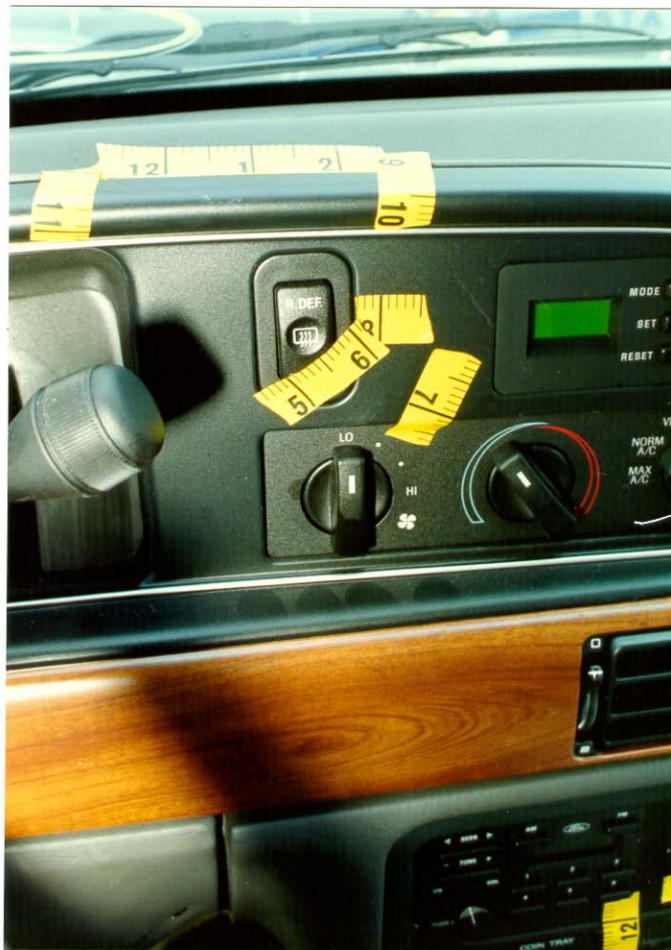
Hand Contact To The Center Upper Instrument Panel, Tissue Transfer.
